SAFETY RECALL F1J

POWER STEERING ECU INSPECTION

CERTAIN 2015 MODEL YEAR HIGHLANDER & HIGHLANDER HV

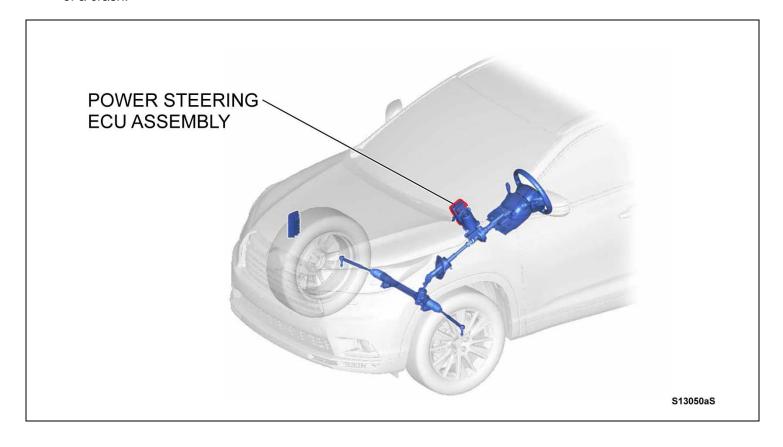
A circuit board for the electric power steering (EPS) in the subject vehicles may have been damaged during its manufacturing process. This can result in the loss of power steering assist. Manual steering is maintained, but the loss of power steering assist results in increase steering effort at low vehicle speeds and increases the risk of a crash.

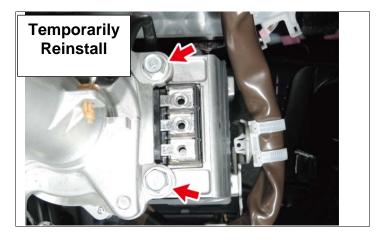
Do not damage the terminals on the steering column when reinstalling the ECU.

a) Reinstall the EPS ECU.
